Research Article

Lale Karataş*, Aydın Alptekin, and Murat Yakar

Investigating the limestone quarries as geoheritage sites: Case of Mardin ancient quarry

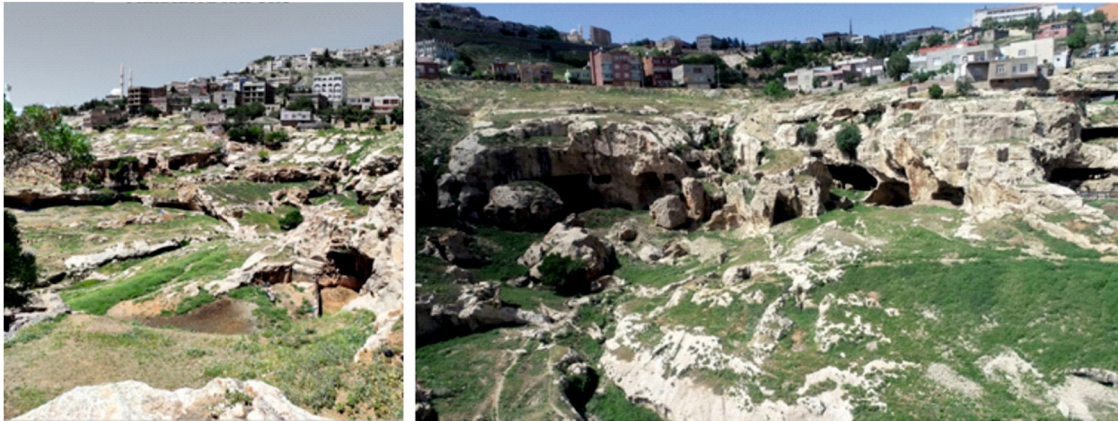
Figure 1: Ancient quarries and caves and surrounding development.

The study area is located in the center of Mardin Province, at 37°18′ north latitude and 40°44′ east longitude. It is surrounded by Artuklu district in the center, Kızıltepe in the southwest, Mazıdağı in the northwest, Savur in the north, Ömerli in the northeast, and Nusaybin in the east. The caves, located in the Savurkapı neighborhood of the Artuklu district of Mardin, in the 1st degree protected area, are present on sloping land in the southeast of Mardin and are currently either closed or used as barns. There are

reinforced concrete structures, a cemetery, and a highway in the upper parts of the region, which is described as an archaeological site and an ancient stone quarry. The project area is currently idle. Since the caves were used as quarries in the old period, their static strength decreased. Reinforced concrete structures are positioned around the cave, which is partially used by the local people. This area is thought to have a great potential for cave tourism for the region [43] (Figure 2).

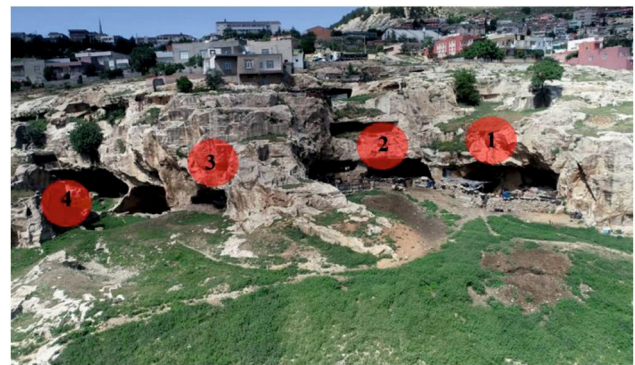
There are four caves in the study area. Located on a sloping land southeast of Mardin, these caves are located in a limestone area where karstification processes form natural karst caves (Figure 3).

Figure 3: Mardin ancient quarries and caves.

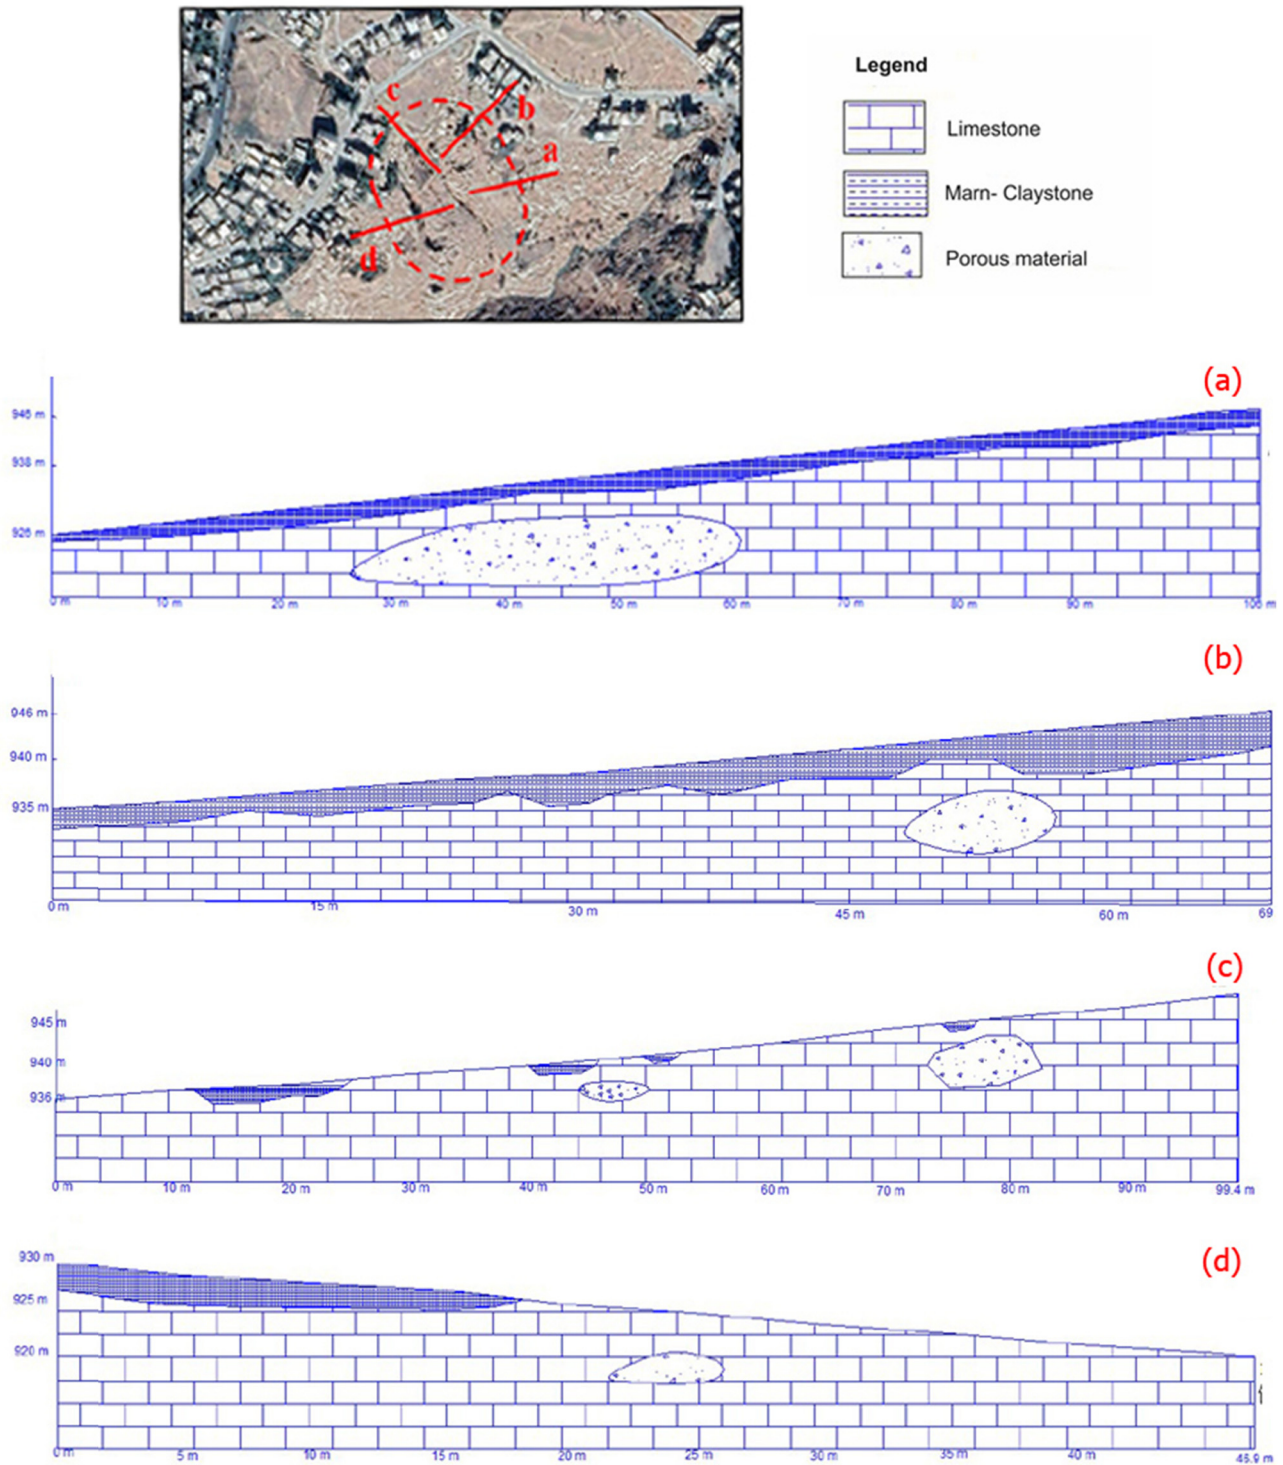
Figure 4: Sections showing the geological structure in the caves obtained from the geological map: (a) section of 1st cave, (b) section of 2nd cave, (c) section of 3rd cave, and (d) section of 4th cave.

Sections showing the geological structure in the caves obtained from the geological map are shown in Figure 4.

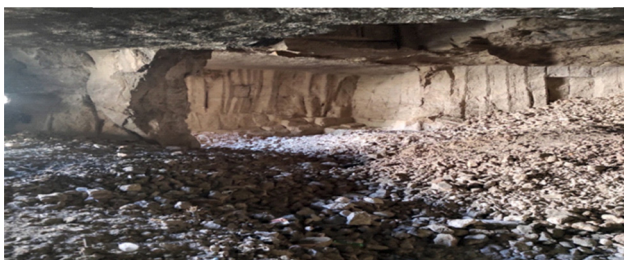
It was observed that the filling material (limestone) was randomly filled on the floor of the 2nd and 3rd caves (Figure 5). In the study area, carbonate minerals were crystallized inside the cave. Calcite minerals were formed in small areas on cave ceilings and walls. In addition, minimal stalactites began to form in the upper parts of the cave due to the water leaking from the cracks.

Figure 5: Filling material randomly distributed in the study area.

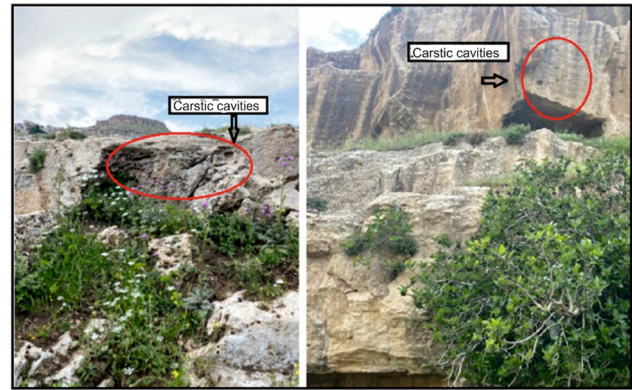
Figure 6: Karst cavities.

As a result of the experimental studies carried out in the ancient stone quarries, it was observed that there were karstic cavities in the caves. Since the cavities are dangerous, it is foreseen to build walking paths to the entrances of existing caves 1–4. Filling areas in existing caves should be emptied and cleaned. Deteriorations on the cave surfaces (plantation, darkening, rusting, etc.)

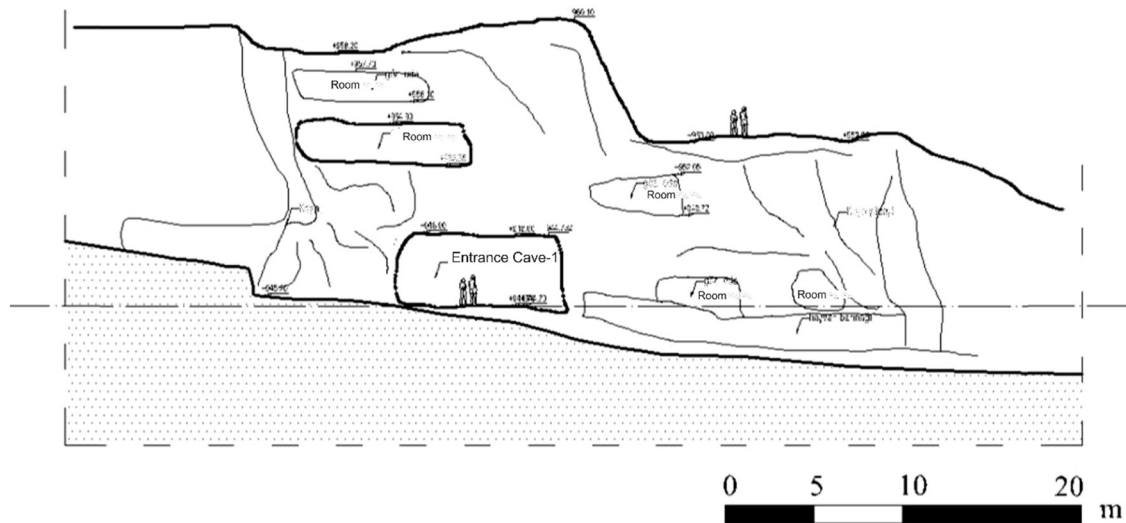
Section A-A shows the cross section of the entrance of Cave 4 (Figure 8). This part provides the entrance to the Cave 4. There are rooms on the upper levels of this cave, both inside and on the façade. In addition, there are reinforced concrete structures in the upper parts of the cave. Like the other 3 caves in the archaeological site, the entrance part of Cave 4 also provides an opportunity to enter the cave with a flat ground.

Figure 8: Architectural Measured Drawing of section A-A.

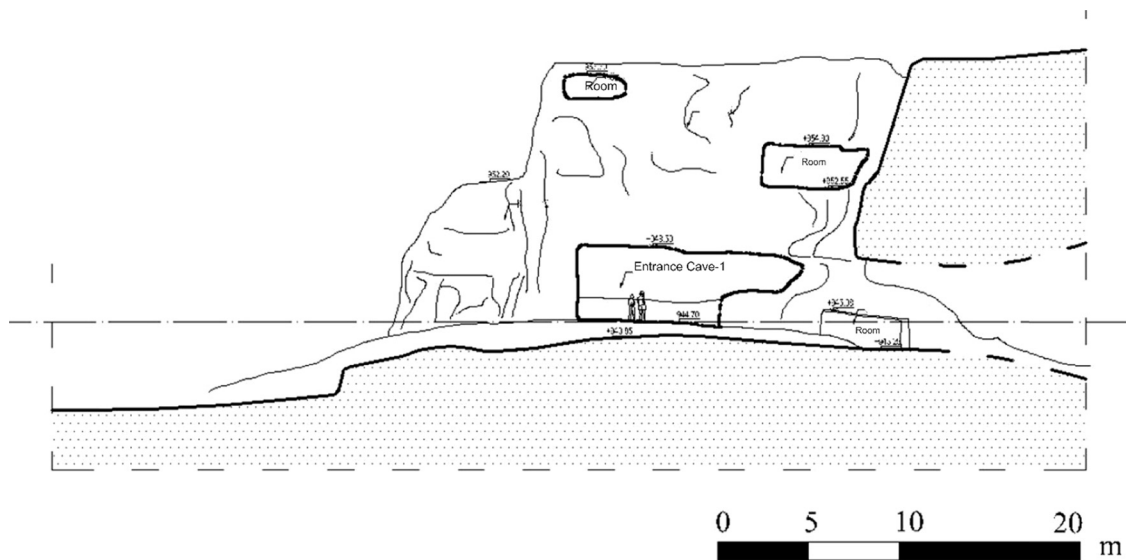
Section B-B gives information about the entrance of Cave 2 and its relationship with the dried stream bed. In the ceiling parts of the cave, stalactites began to form as colonies due to cracks and leaks. This cave, which is divided into five rooms within itself, is the only cave actively used for animals (Figure 9).

Figure 9: Architectural measured drawing of section B-B.

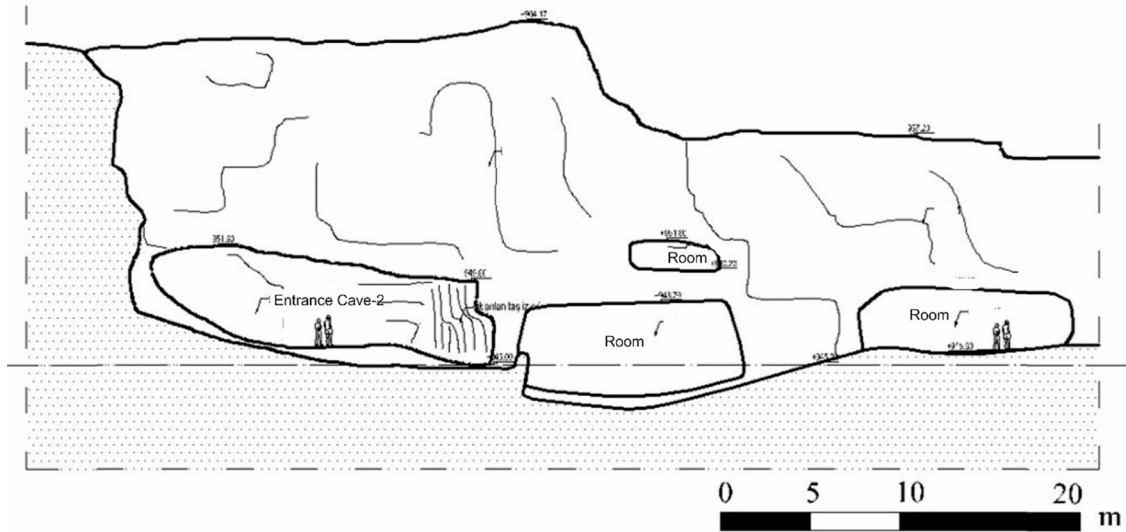
Section C-C cuts the entrances of Caves 1 and 2 in parallel and gives information about the relationship of these caves with each other. The rough topography shows that architectural elements such as stairs, ramps, etc., should be resolved in the next step in terms of circulation. From the photographs shown in the sections and annexes, traces of cut stones are evident on the surfaces that indicate that the caves were used as quarries (Figure 10).

Figure 10: Architectural measured drawing of section C-C.

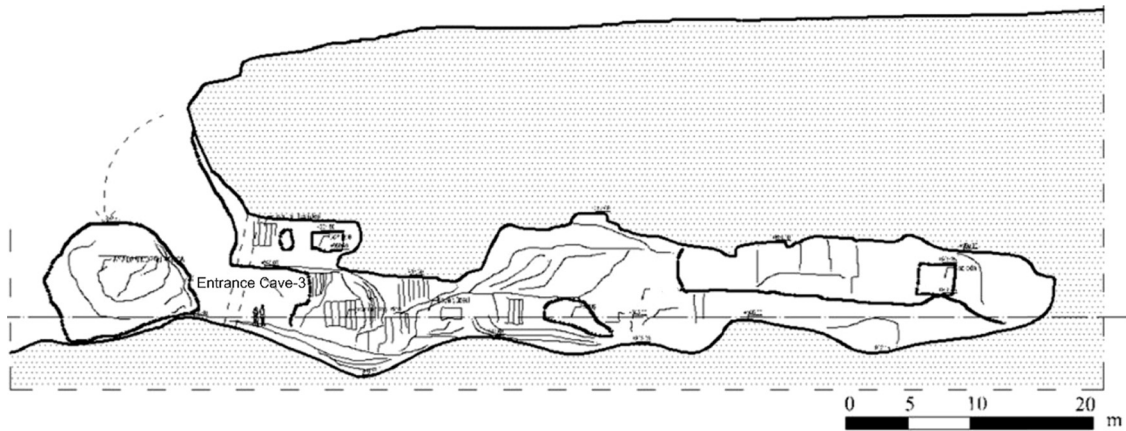
Section D-D cuts the Cave 3 from the middle part of the entrance and gives information about the topography of the cave. There are rooms in the upper elevations of the Cave 3, which shows the greatest variation in the ground elevations of the cave. On the ground, there are pits and partially hilly areas. It is thought that at the entrance of this cave, a large green rock mass was torn from the surface due to the cracks-crevices and tectonic movements (Figure 11).

Figure 11: Architectural measured drawing of section D-D.

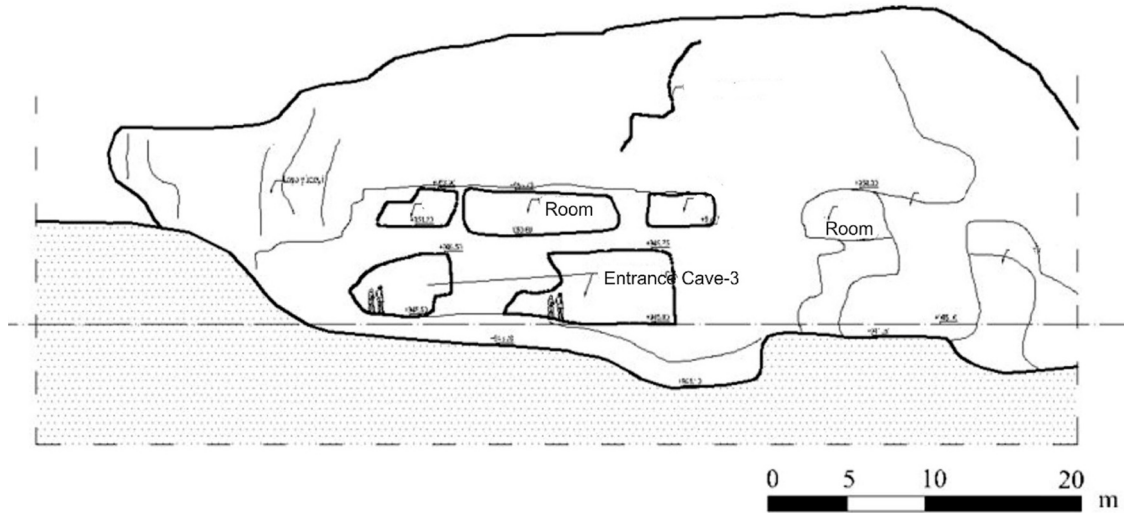
Section E-E describes the relationship between the entrances of Caves 2 and 3. Some of the sewer pipes

flow into the gap on the walls of Caves 2 and 3 and merge with the dried stream bed. Due to the dirty water flowing in the area, algae have formed on the surfaces. Relevant analyses were made in order to remove the sewer infrastructure system without damaging the area, and a recommendation was made regarding the sewer infrastructure system in the conclusion part of the study (Figure 12).

Figure 12: Architectural measured drawing of section E-E.

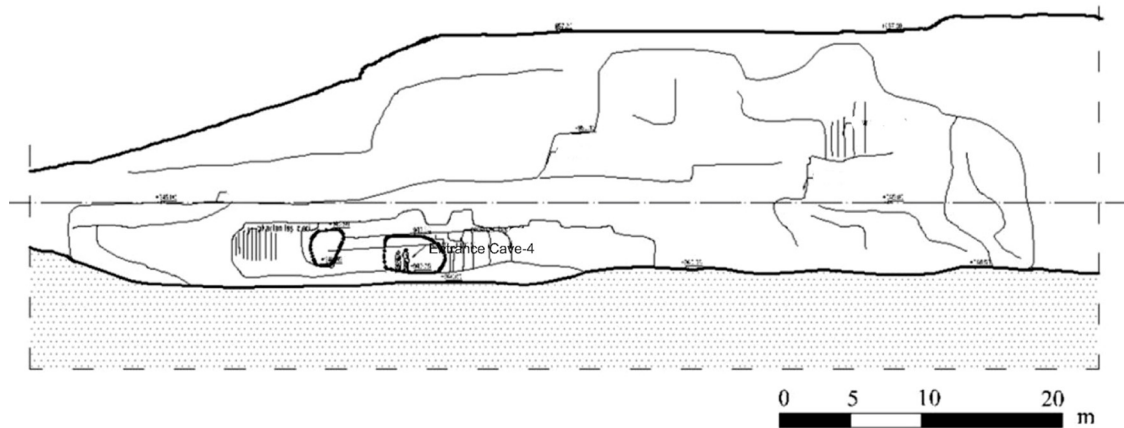
Section F-F passes parallel to the entrance of Cave 4. This cave is the farthest of the 4 caves with respect to the entrance point to the area. The entrance to the cave is provided through the mouth 2. The entrance part is met with a large area and gives direction with 2 tunnels (one of which is closed) and 1 room. Cold air flows through the open tunnel (Figure 13).

Figure 13: Architectural measured drawing of section F-F.

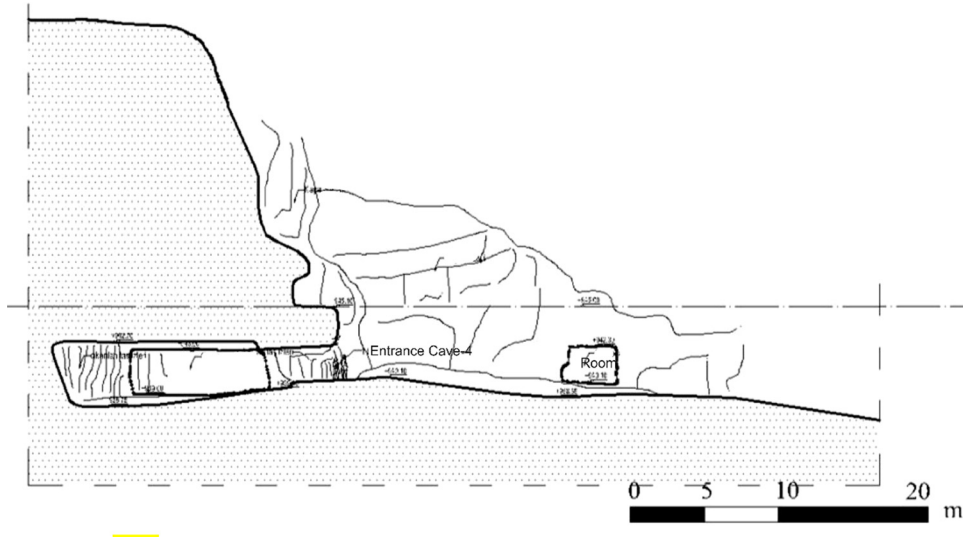
Section G-G cuts Cave 4 longitudinally. Consisting of 2 mouths, this cave has 1 chamber (room) and 2 tunnels (one of which is closed). The open tunnel opens to a wide and high area as a result of a distance of approximately 10 m and leads to small-large and continuous chambers within that area (Figure 14).

Figure 14: Architectural measured drawing of section G-G.

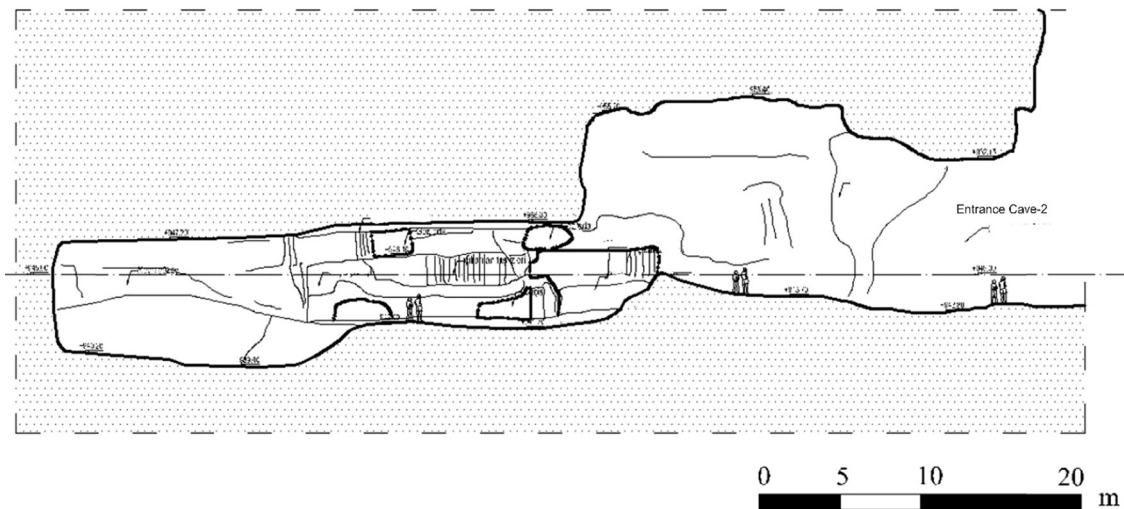
Section H-H includes the entrance part of Cave 2 and cuts it parallel to the long side of the cave. It has been determined that there is a tunnel (pass) in this cave, which has a wide and high mouth (Figure 15).

Figure 15: Architectural measured drawing of section H-H.
